Manhole Inspection Summary

Manhole # S21MM_021MH

Insp Date: **7/2/07 12:46 PM**

Location Address: **1571 RICHLAND ST**

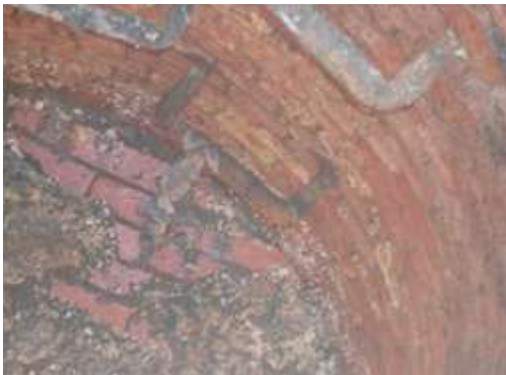
Defect 3

☒ **Evidence Of Surcharge** Depth: **1** (ft.) ☐ Active Surcharge Present

SURCHARGE EVIDENCE ON STEPS

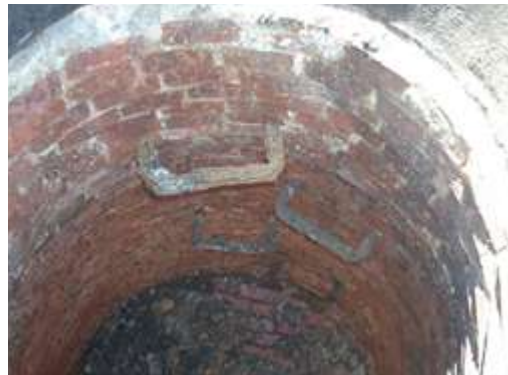
Defect 2

Count: **4** Missing: **0** ☒ **Corroded**

CORRODED STEPS

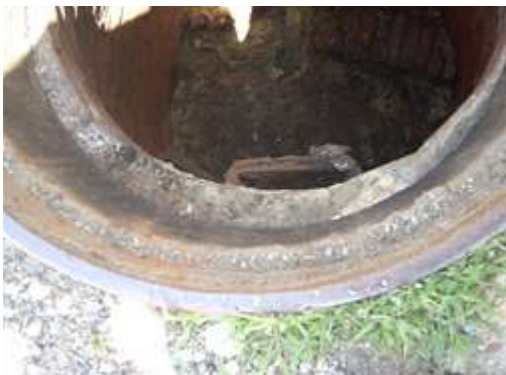
Defect 1

Offset: **2** (in.)

FRAME OFFSET

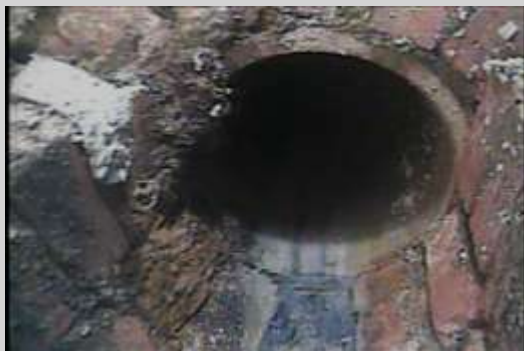
3 O'Clock Inflow

Pipe Height: **8.4** (in.) Rod and Bar (Angled)
Pipe Material: **Clay** ☐ Pipe Lined
Invert Depth: **7.56** (ft.) Flow Characteristics: **Slow**
Deposits: ☒ None ☐ Mud ☐ Sludge ☐ Debris ☐ **Grease**
Silt Depth: (in.) Deposits Extent:
Infiltration: **None** Pipe Seal Cond: **Sound**

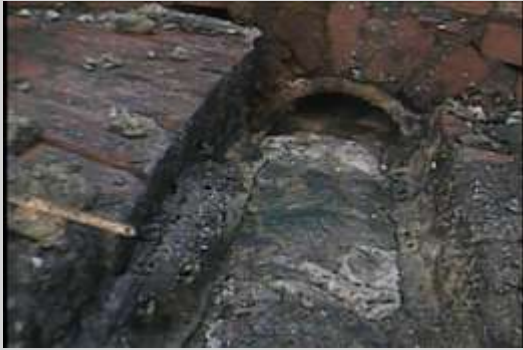
6 O'Clock Inflow

Deposits: ☐ None ☐ Mud ☐ Sludge ☐ Debris ☒ **Grease**

Silt Depth: **6** (in.) Deposits Extent: **Heavy**
